Case 262 : Narrative

Case Vehicle (A): 2000 Honda
Type: CR-V ES, AWD, 4-door SUV
Driver: 21-year-old female
CDC: 99-0000-0, 02-RDAW-3

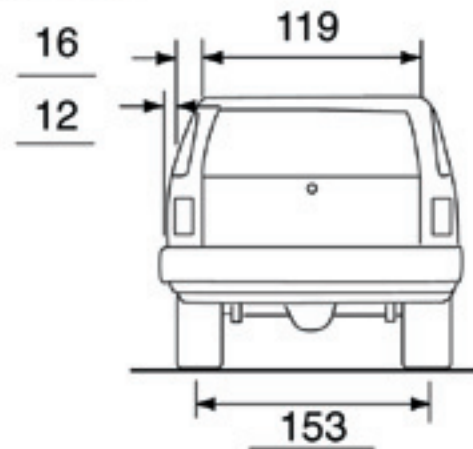
Damaged when towing vehicle out of ditch
